ITAIPU HYDROELECTRIC PROJECT

Engineering Features

ITAIPU BINACIONAL
1994

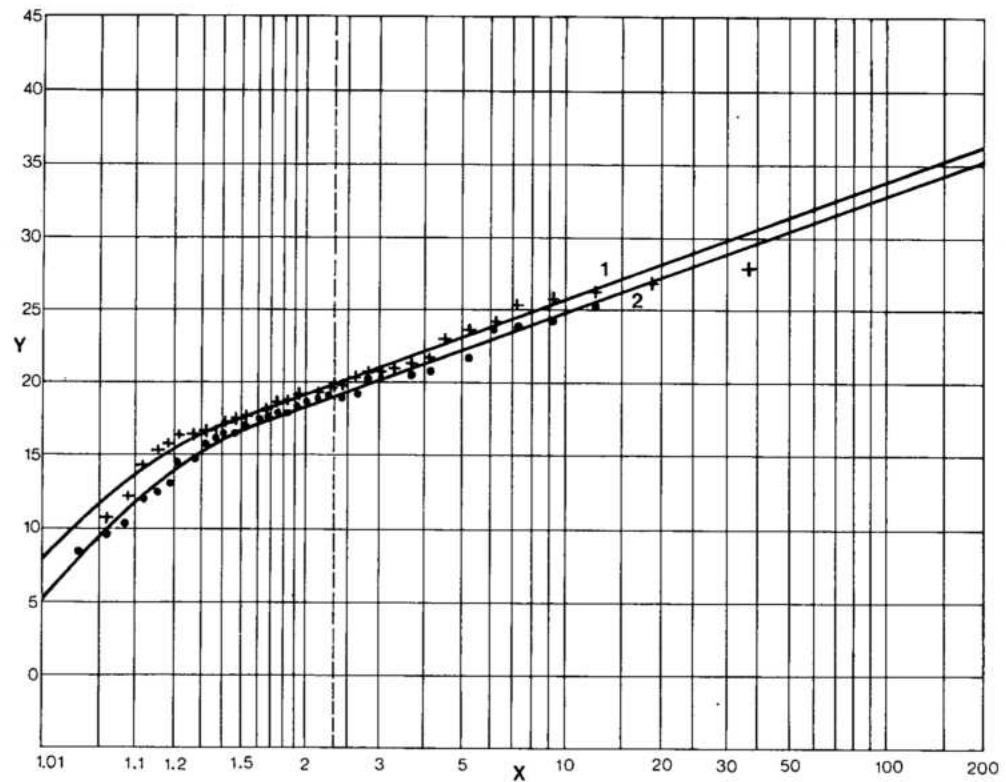
Fig. 2.12 Annual frequency curves of maximum average daily discharge

— Natural condition — Ultimate development without Ilha Grande reservoir — Ultimate development with Ilha Grande reservoir

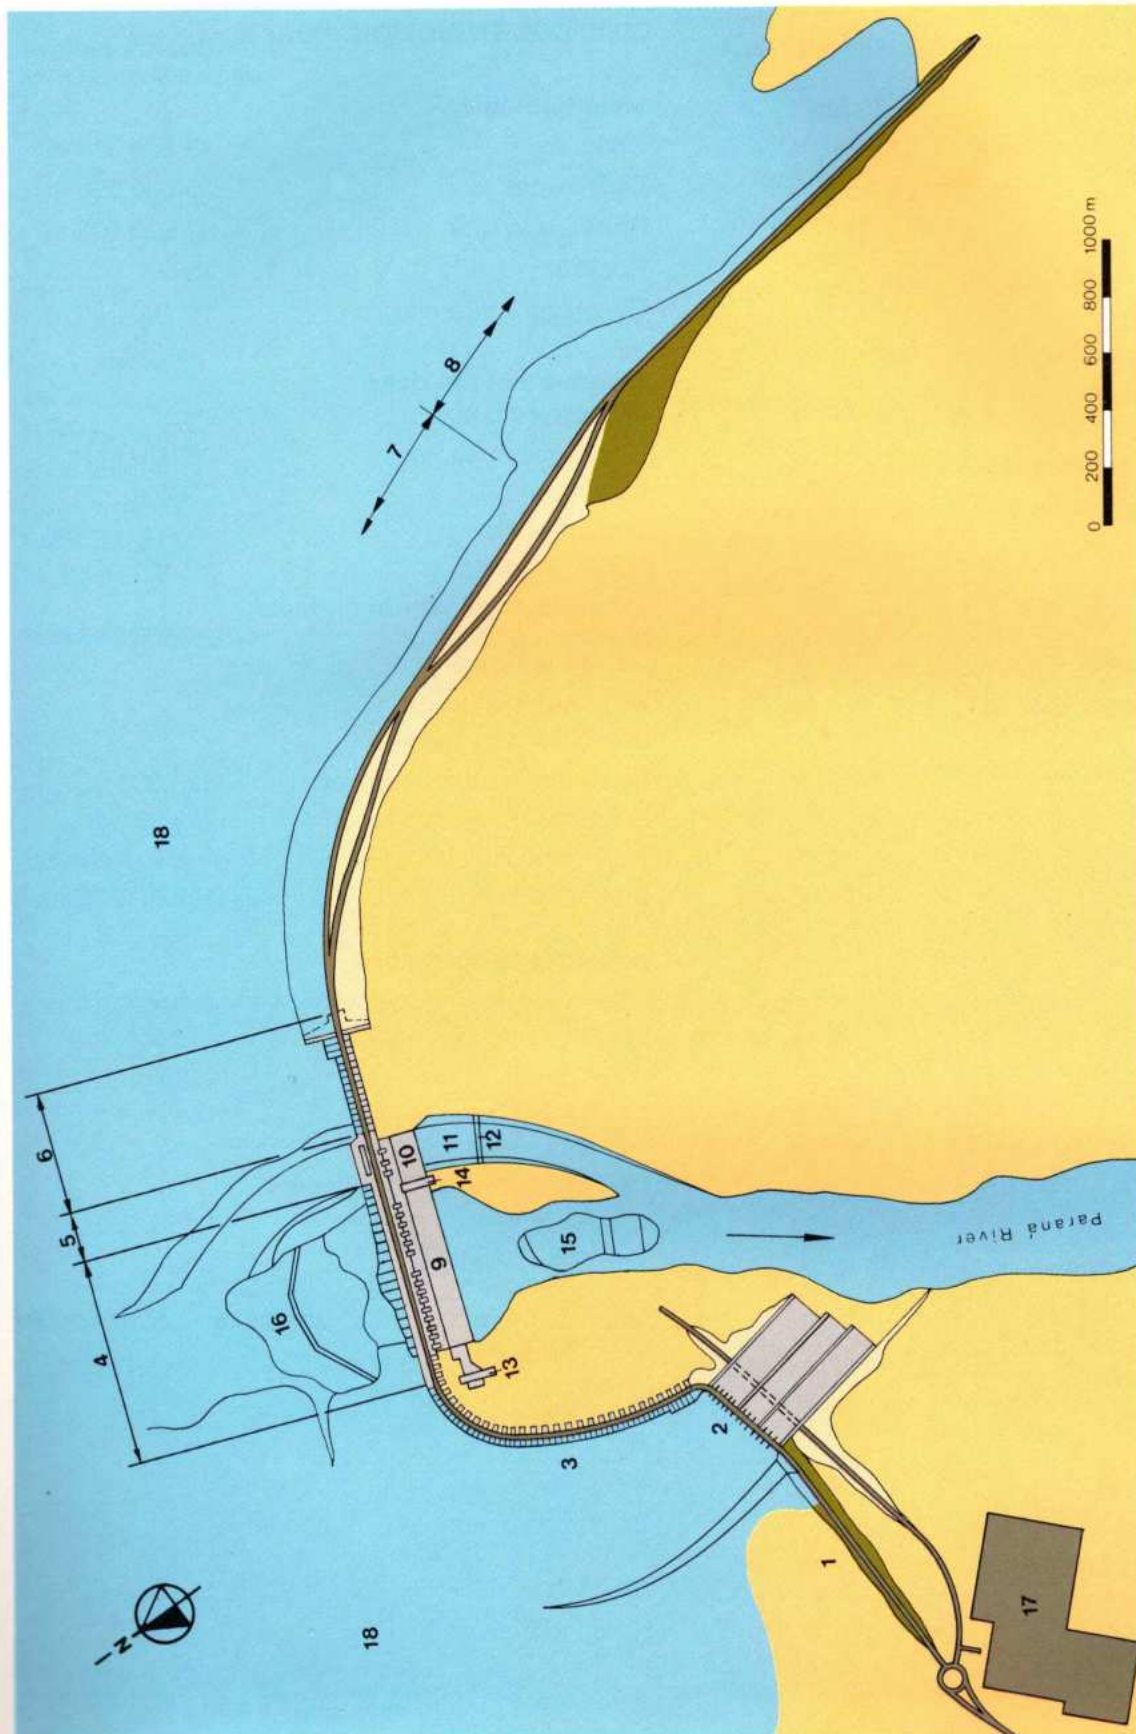
Fig. 3.2 Project general layout

Project drainage basin	820 000 km ²
Average annual precipitation	1400 mm
Average annual temperature	22°C
Maximum temperature	40°C
Minimum temperature	- 4°C
Average annual relative humidity	75 %
Climate	Subtropical

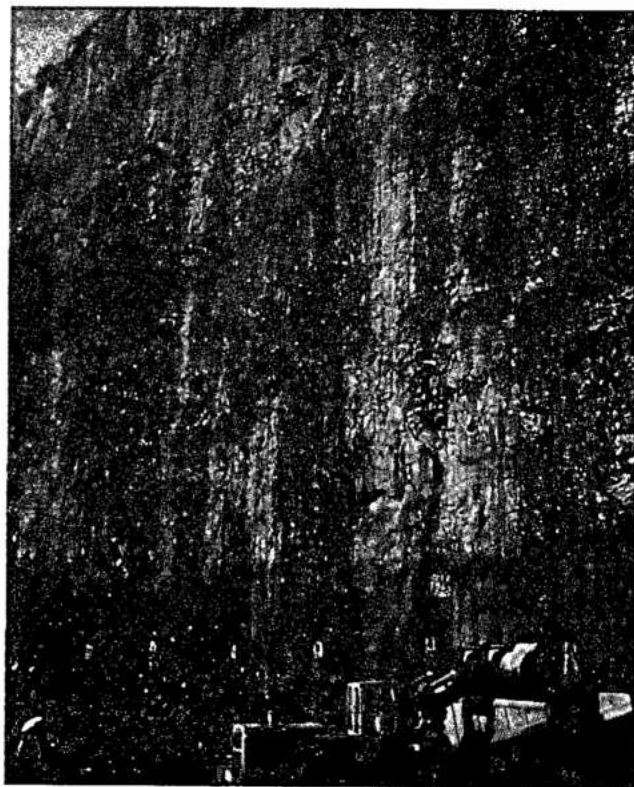
Left side of diversion structure between El. 105 and El. 125. Discontinuity D is visible on the left side of the photograph

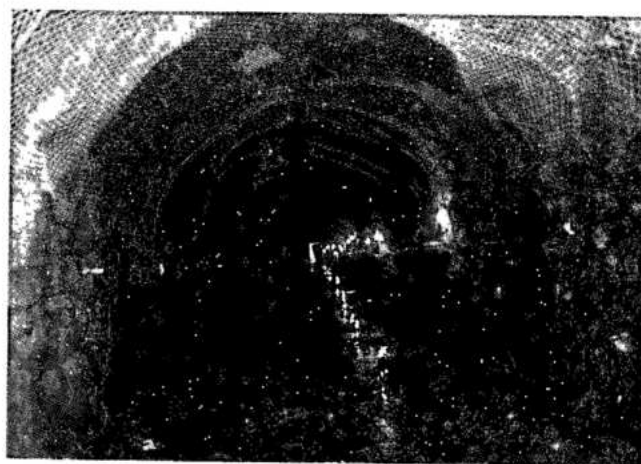
Systematic rock stabilization was applied at each tunnel heading immediately after mucking out. Typically, this consisted of rock bolts 2.4 to 3.2 m long, 16 to 25 mm in diameter, and a steel wire mesh tied by the same bolts or by clamps. When highly fractured rock was encountered, pre-stressed rock bolts were installed from the work face with a forward inclination and grouted, which resulted in improved performance and faster rate of advance. In stretches of rock where fracturing of single rock blocks of small volume ($< 0.5 \text{ m}^3$) occurred and where the installation of rock bolts was impractical,

Tunnels for transverse keys

flat steel bars were installed, tied by bolts at both ends and molded to fit the contour of the tunnel. More unstable rock conditions required application of shotcrete, either as a preliminary treatment before drilling holes to place rock bolts, or to supplement other stabilization measures.

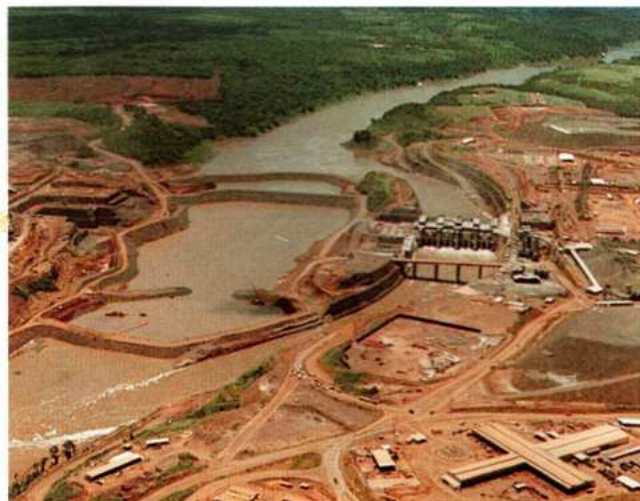
The closing of these dikes immediately after the opening of the diversion channel was estimated to require about $1.2 \times 10^6 \text{ m}^3$ of rock. This work was scheduled in two phases. Initially quarry-run material from the right bank would be placed. When scouring conditions were reached, placing would be carried

Diversion and closed cofferdam dikes

out from both banks with larger selected materials simultaneously in both dikes B and D at a controlled rate so that the loss of head was the same at each dike. As indicated by the schedule, 15 days would be required to place the $400\,000 \text{ m}^3$ estimated for the first phase, and another 15 days for the remaining $800\,000 \text{ m}^3$ of selected rock. This consisted of rock ranging in size from 0.6 m to 1.2 m. To ensure the final phase of closure, large boulders and 4000 tetrahedrons were to be provided. It was estimated that dike B would close at El. 115, assuming that the flow of the Paraná river during closure in early November was about $12\,000 \text{ m}^3/\text{s}$ or less. Immediately thereafter, this dike would be raised to a safe elevation, which might reach El. 126, depending on the river flow. This elevation corresponded with the most unfavorable downstream water levels for a discharge of $22\,000 \text{ m}^3/\text{s}$. The recurrence probability of this discharge was about once in 10 years, which was considered appropriate for the period of cofferdam construction. Simultaneously with raising dike B, rockfill placement would be concentrated on dike A, so as to complete it within one month. This activity was critical to the impermeabilization of the upstream cofferdam since it needed to be completed before dredging could commence between the dikes in the deep channel of the river.

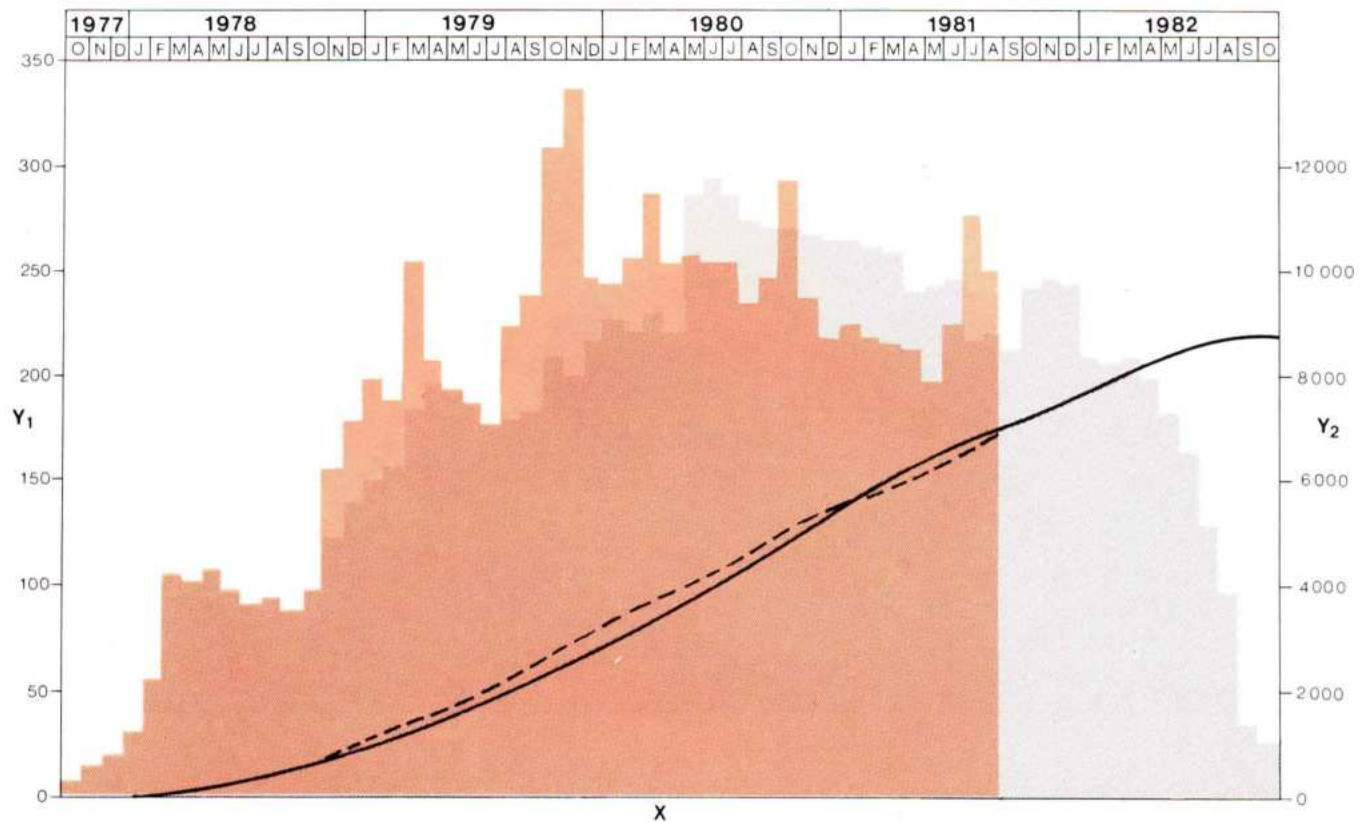
Fig. 5.10 Comparison of programmed and actual concrete placement to 1982

Fig. 5.10 shows a comparison between the volumes indicated in the basic program and the monthly production actually achieved through October 1982, which was the period of maximum production. Actual concrete placement rates were faster than anticipated, especially during 1979–80, mainly because of early completion of the foundations for the main dam and the powerhouse in the river channel. Thus concrete production peaked earlier than anticipated.

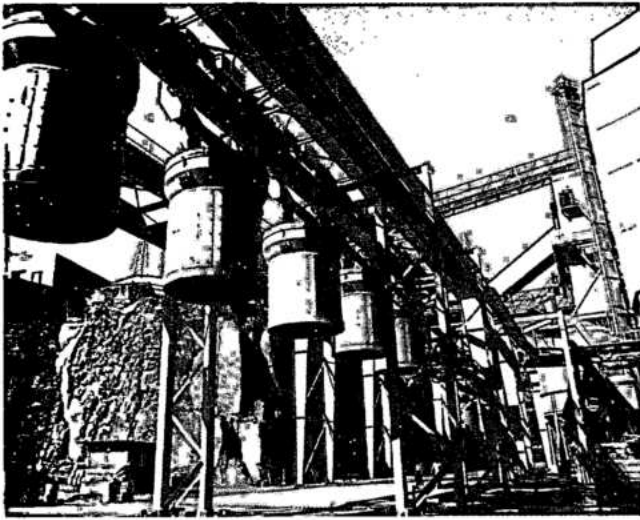
On the right bank, only one configuration was utilized, with the monorail installed along a continuous dock at El. 165.

Monorail in operation

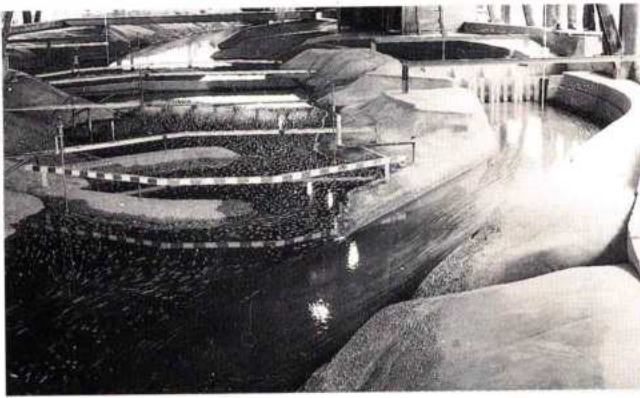
Span	20.70 m
Height (set of six elements)	21.53 m
Number of elements per opening	6
Number of sets	2

The geometric layout of the diversion channel, the configuration of its entrance and exit, the elevations and the grade of its bed were established after a series of tests on a 1:100 scale hydraulic model at CEHPAR (Centro de Hidráulica e Hidrologia Prof. Parigot de Souza) Laboratory in Curitiba, Paraná, Brazil. The model represented a 3000 m stretch of the river and included the main cofferdams, the diversion channel and the diversion structure. The width of the bed of the channel tested was 150 m from its entrance up to the diversion structure,

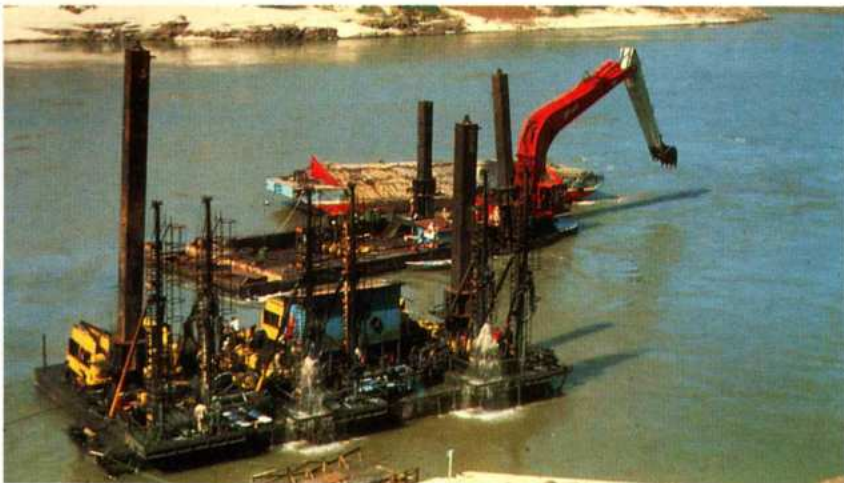
Underwater excavation

Concurrently with the excavation of the diversion channel in the dry, underwater excavation lowered the river bed at its entrance and exit. Approximately 900 000 m³ of material was excavated by drilling and blasting in up to 10 m of water. The excavated material was removed by a barge-mounted backhoe and hauled to designated areas away from the location of the permanent works.

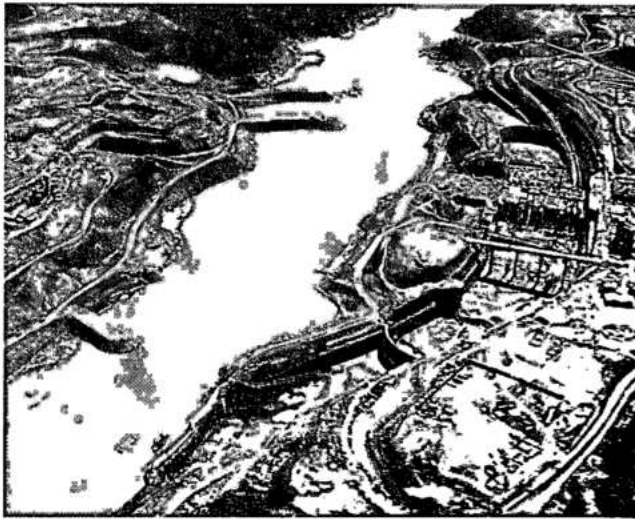
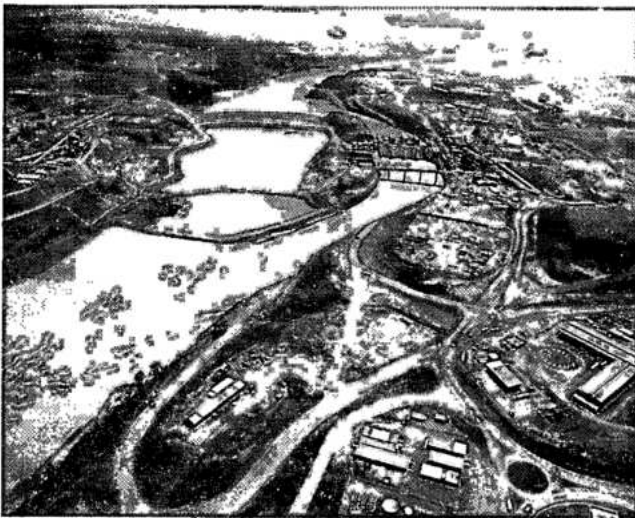
Removal of alluvium from clay core foundations

With all dikes closed, a crucial step was the removal of alluvial sand and boulders from the foundations,

Sequence of construction of the dikes for the main cofferdams

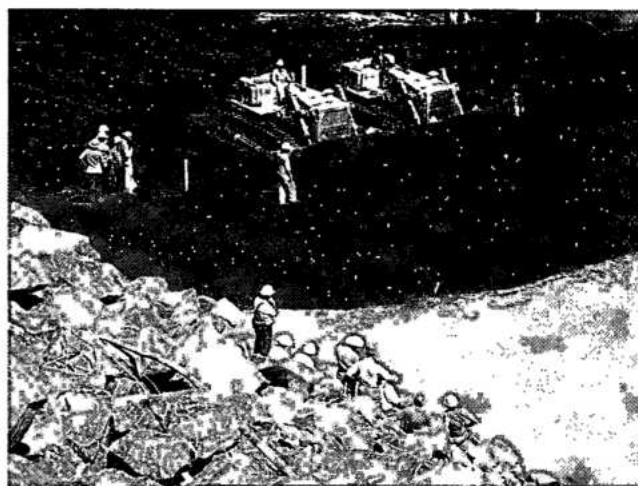
- The placing level of the clay at the front should not be more than 1 m above the water.
- Windrows of two or three truck loads or of about 50 to 60 m³ would be sufficiently large.
- Two or four heavy bulldozers working in pairs could adequately handle this size of windrow.
- The bulldozers should drop their blades and push downward to squeeze the material and make it slide down "en masse".
- For the first 2 or 3 days after the start of continuous placement a thin layer of material would extend along the river bed for about 150 m from the front. This material would be almost slurry and be pushed away by the advancing clay. About 2% of the material could be lost in this manner.
- The following characteristics of the clay should be expected after placement: high air content and negative pore pressures, moisture content 5 to 8%

Placing clay in water

higher than before placement, high compressibility and continuous long-term settlement and relatively high impermeability.

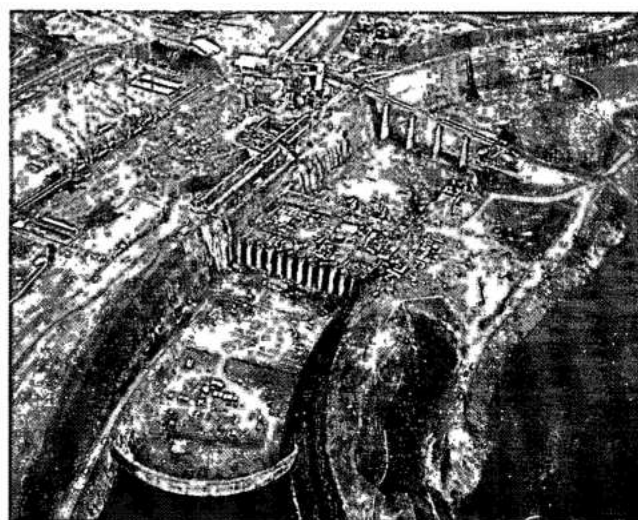
The five central blocks of each arch dam, were slip-formed except for the top 2.5 m. The average rate of progress of the slip-forms was 10 cm/h. Details of the slip-forming technique are discussed in Chapter 5 and in Chapter 11.

Other than the joint grouting piping and waterstops, the only embedments in the arch dams were the plastic pipes in which explosives were inserted for demolition. The arch dams, containing 22 000 m³ of concrete in the upstream dam and 13 000 m³ in the downstream dam, were completed in 4.5 months. Because of the relatively thin sections of both arches, see Fig. 6.19, by July 1982 the concrete had cooled to near ambient temperatures and the contraction joints had opened sufficiently for grouting at pressures of about 35 N/cm². A month later, the channel between the rock plugs and arch cofferdams was filled with water.

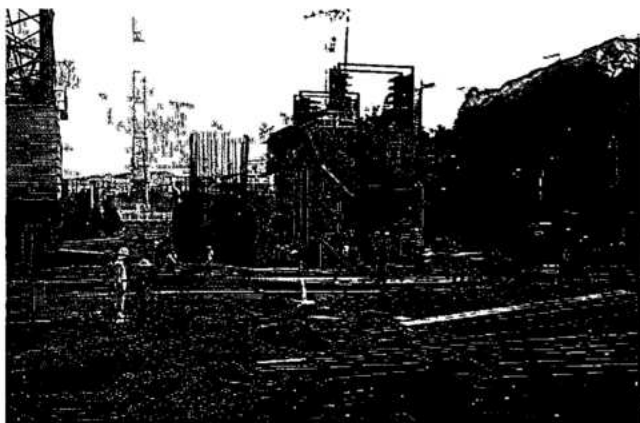
Slip forming of diversion structure pier

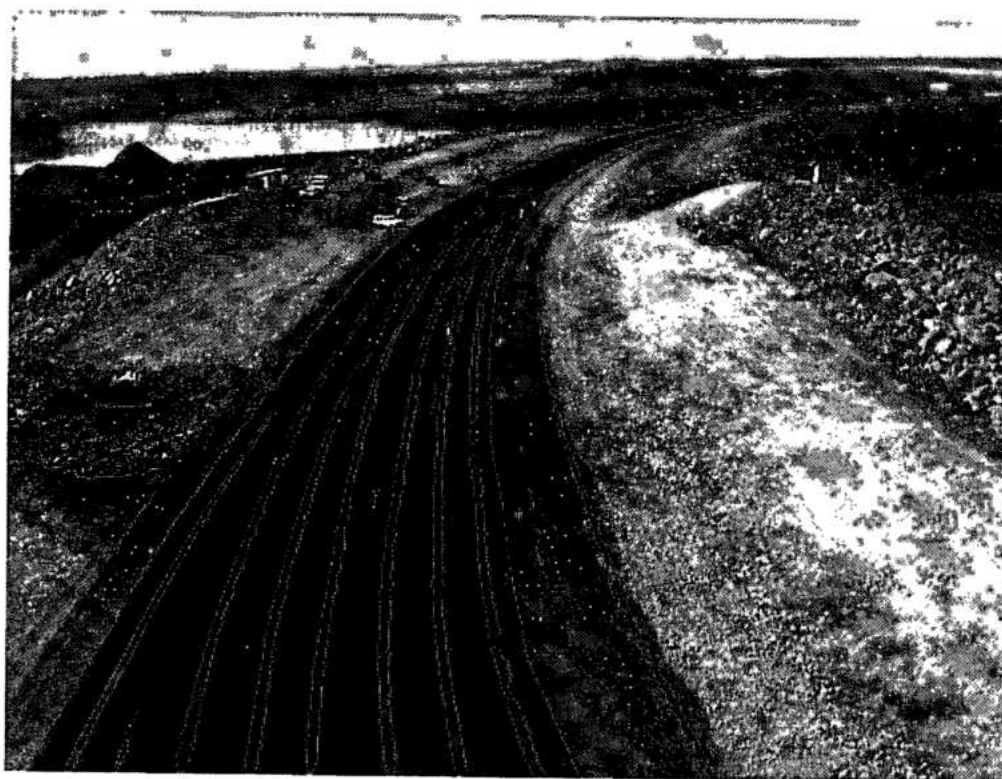
Fig. 7.1 Rockfill dam - Typical cross section

As shown in Fig. 7.1, the rockfill dam has a central core of compacted clay with a vertical downstream face and 1V:0.6 H upstream face. The thickness of

Clay core of rockfill dam

The foundations for the impervious core, the filter and the transition zones were sound rock, while the rockfill shells were based on slightly weathered rock reached after removal of ripable weathered material.

Maximum layer thickness, after compacting	10 cm
Tamping roller	TC - 15B pad type
Number of passes	6
Moisture content	Range 0.5% above and 2% below proctor optimum

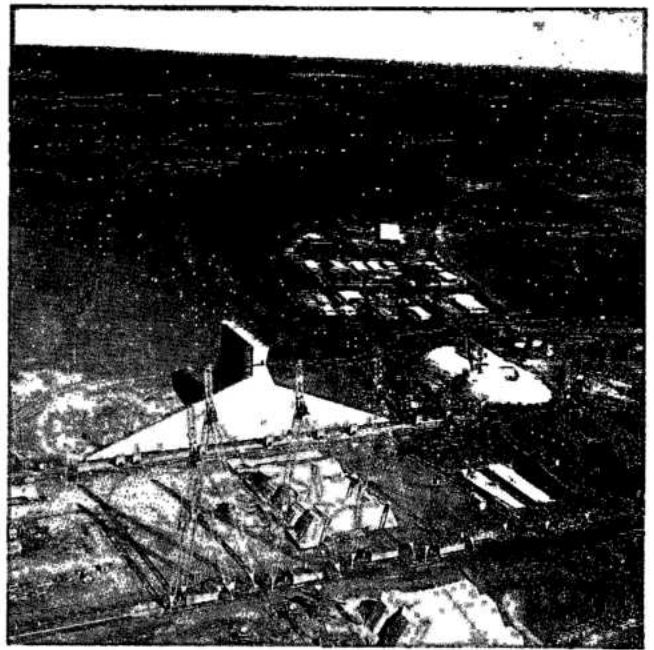
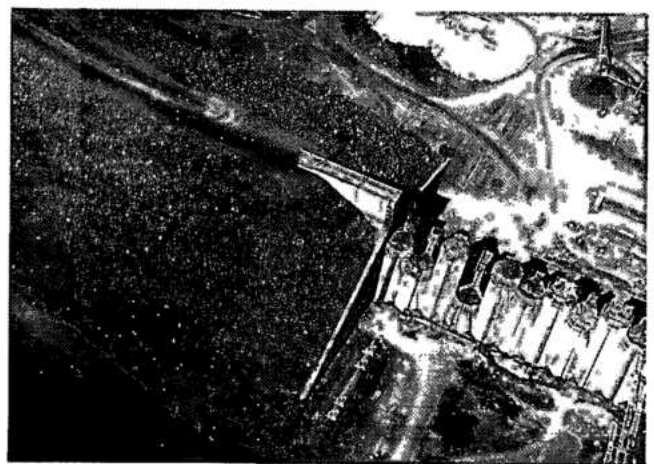
Efficient contact was achieved by overlapping the clay core of the rockfill dam with the upstream face of the concrete. In the transverse section this overlap is 8 m wide at the crest, increasing with the depth in accordance with the upstream slope of the core which was increased to 1 V:1 H. The transverse contact width between clay core and foundation at the overlap was 0.65 times the reservoir head.

The longitudinal contact between the impervious clay core and concrete, along the upstream face of the concrete interface, is equal to the reservoir head.

Transition of rockfill dam with concrete dam

Grout and drainage curtain holes were drilled from the gallery in the concrete transition at El. 155. The grout curtain consists of three rows of 75 mm diameter holes (primary, secondary and tertiary) 23 m deep with a minimum spacing of 2.5 m. From the same gallery one row of 100 mm diameter drainage holes were drilled, 15 m deep and 3 m spacing. These drainage holes were topped by 125 mm diameter steel tubes which acted as drill guides and also facilitated measurement of leakage flow. An upstream grout curtain of two rows of 75 mm diameter holes, 6 m deep with 2.5 m maximum spacing extends from the concrete transition beneath the impermeable core to meet with the grout curtain of the rockfill dam.

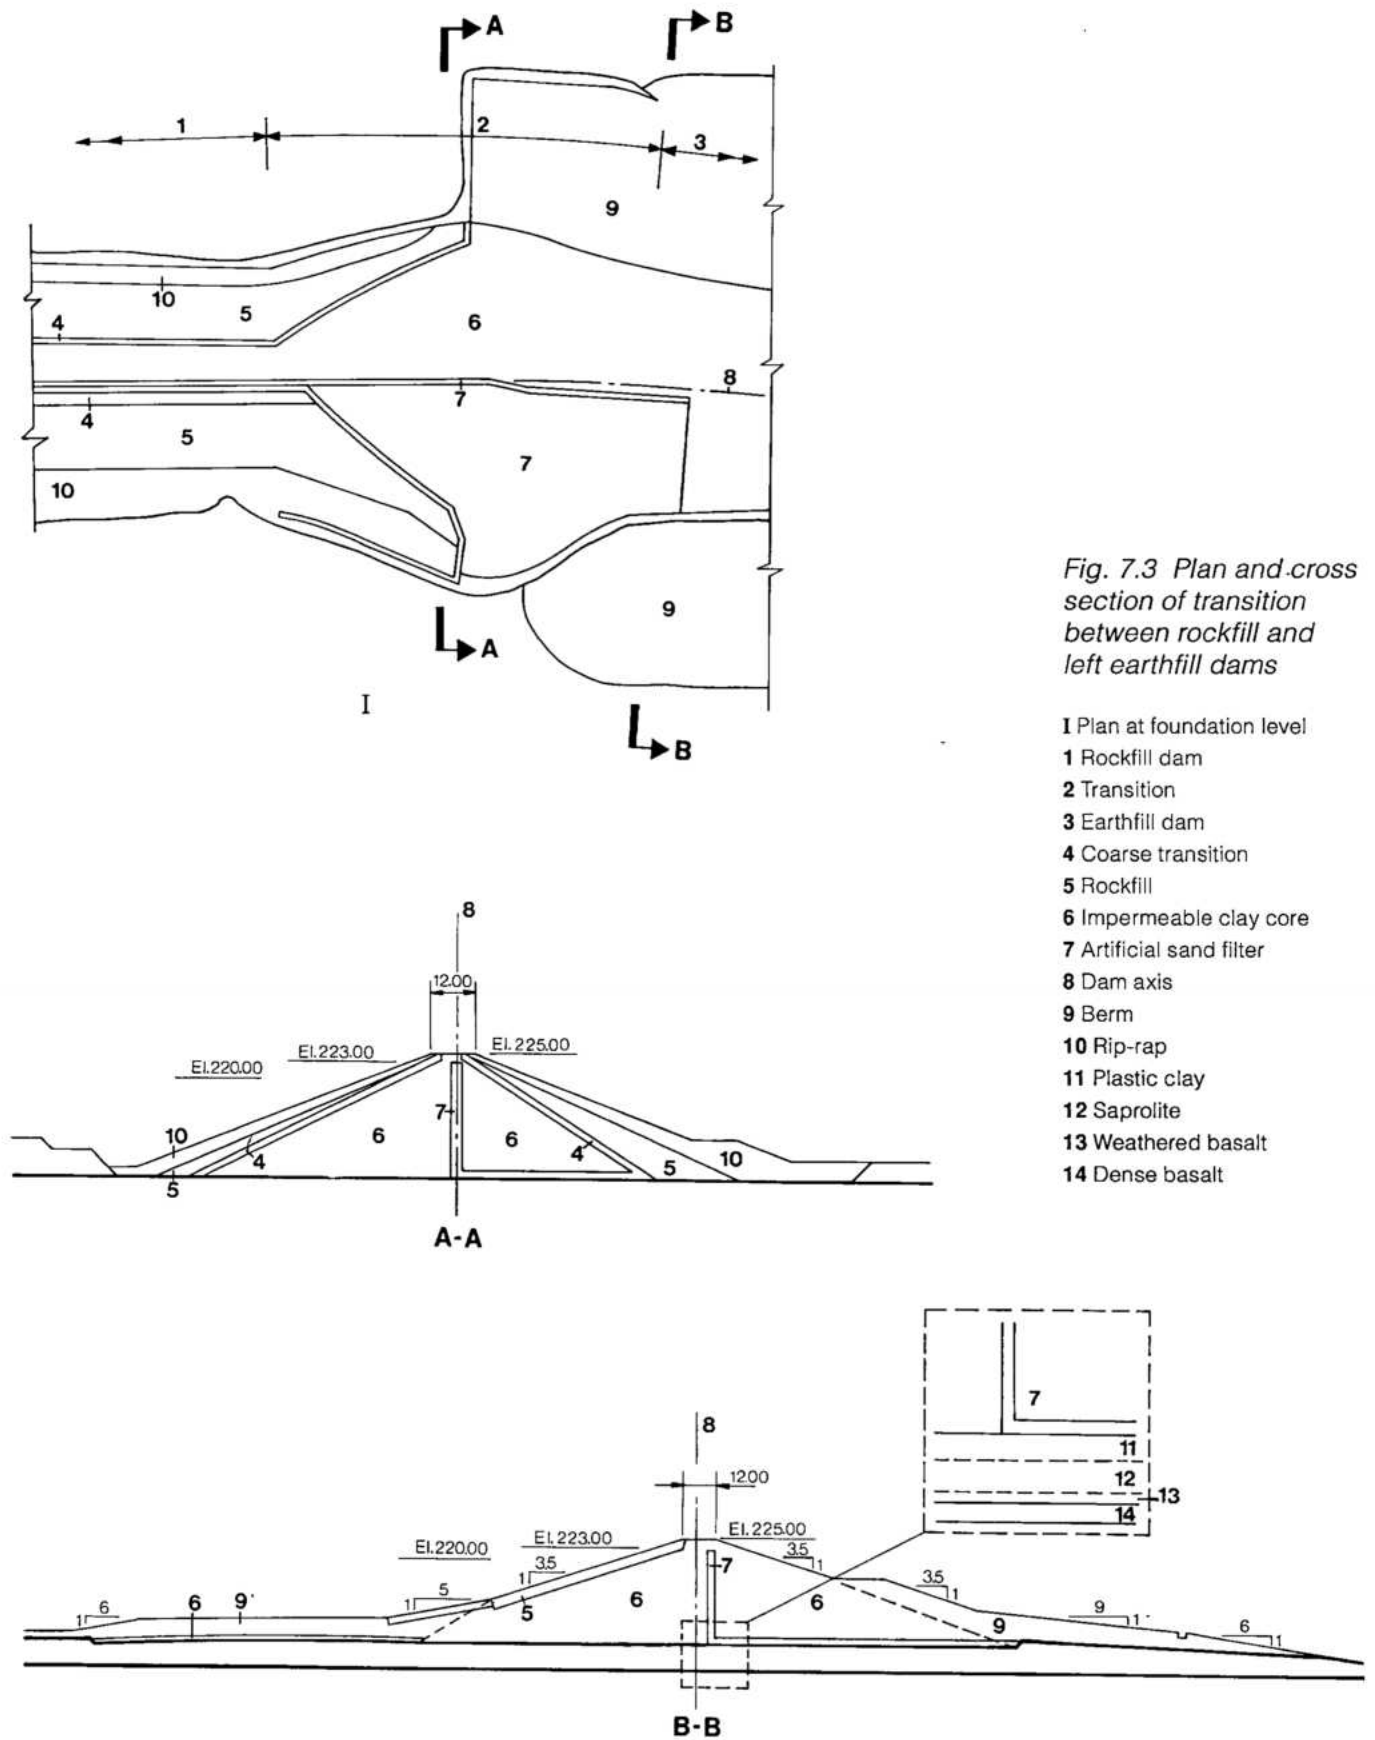
Fig. 7.3 Plan and cross section of transition between rockfill and left earthfill dams

For most of the transition portion, the overburden of residual soil was excavated to sound rock. About 100 m from the earthfill dam, the excavation was sloped up to firm soil.

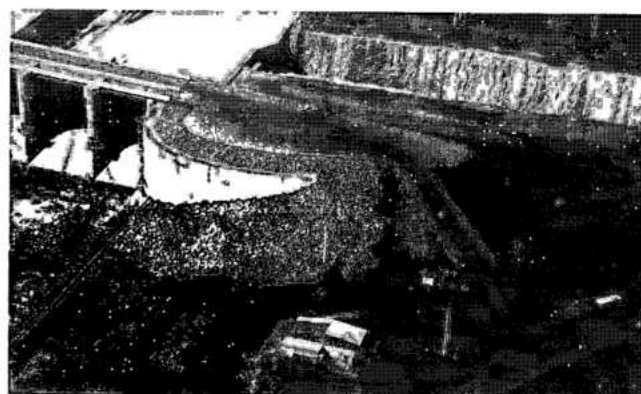
The space between the impervious clay core and the external upstream slope of the earthfill is filled by clayey material which becomes gradually thicker and higher, with the external slope deviating from the alignment at the earthfill dam and the impervious core decreasing in thickness as excavation of the foundation deepens.

Transition of right earthfill dam with spillway

On the downstream side, starting at the earthfill dam, the rockfill becomes thicker and higher as the core diminishes with the deepening of foundation excavation. At the point where excavation meets the rock, the rockfill reaches its maximum height and width. Accompanying the change of internal zoning, the external downstream slope becomes steeper varying from 1 V:3 H to 1 V:1.8 H.

At this section, the internal drainage system comprises a vertical chimney filter 2 m wide and a drainage blanket 1 m thick which extends from the foot of the vertical filter to the extremity of the downstream fill. It acts also as a transition between the core and foundation soil.

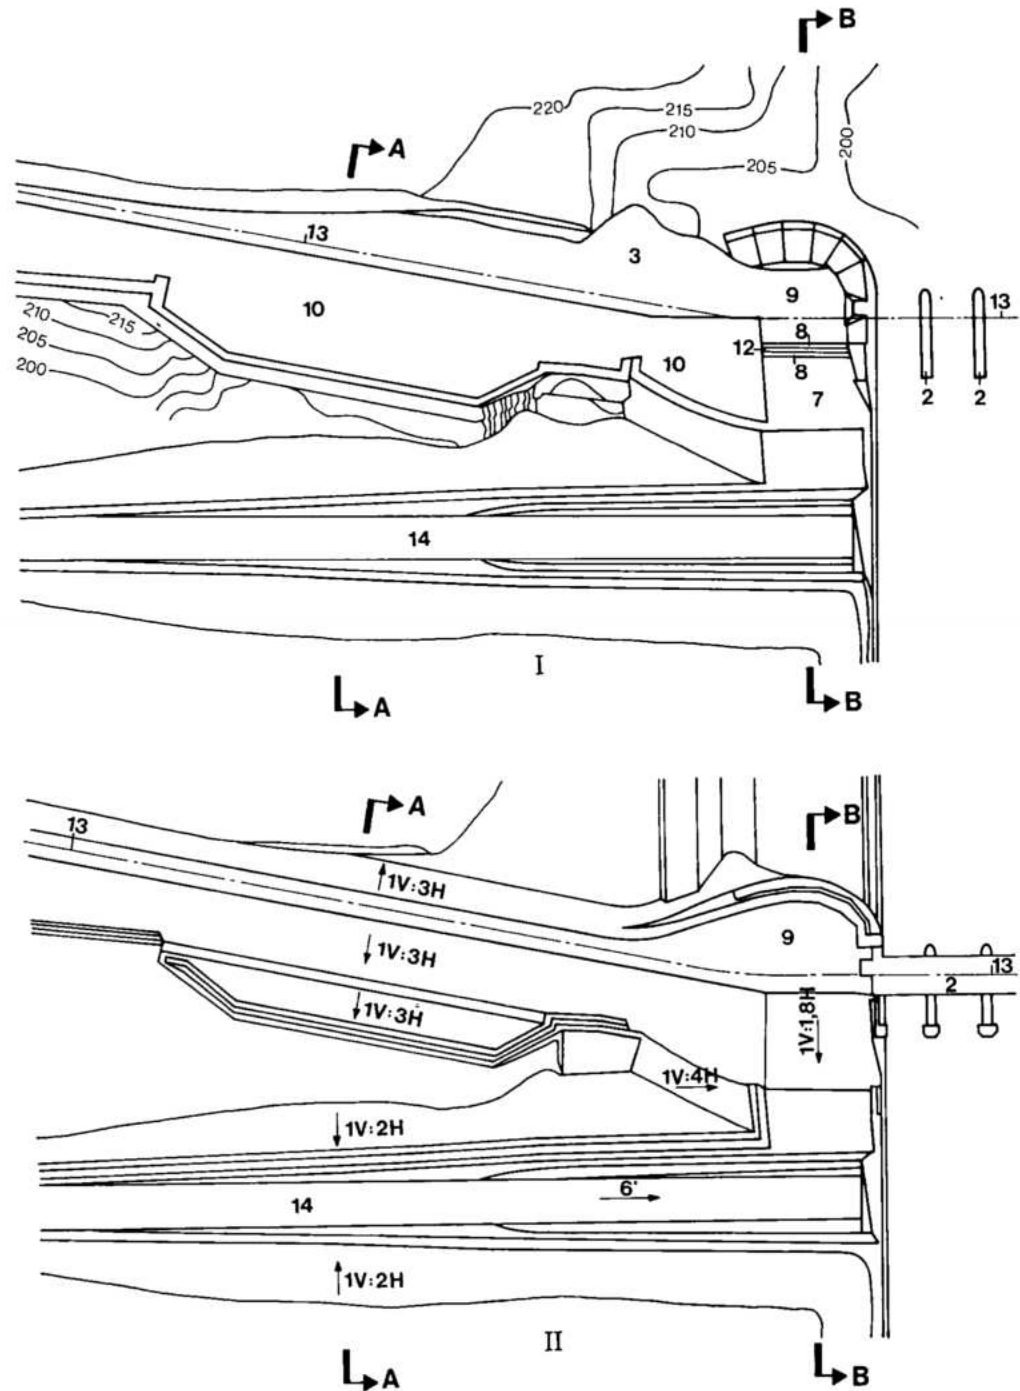
Fig. 7.6 Transition between right earthfill dam and the spillway - Plan view (for nomenclature, see Fig. 7.5)

Plans and sections of the earthfill dam on the right flank, between the right side abutment and the spillway wall, are shown in Fig. 7.6.

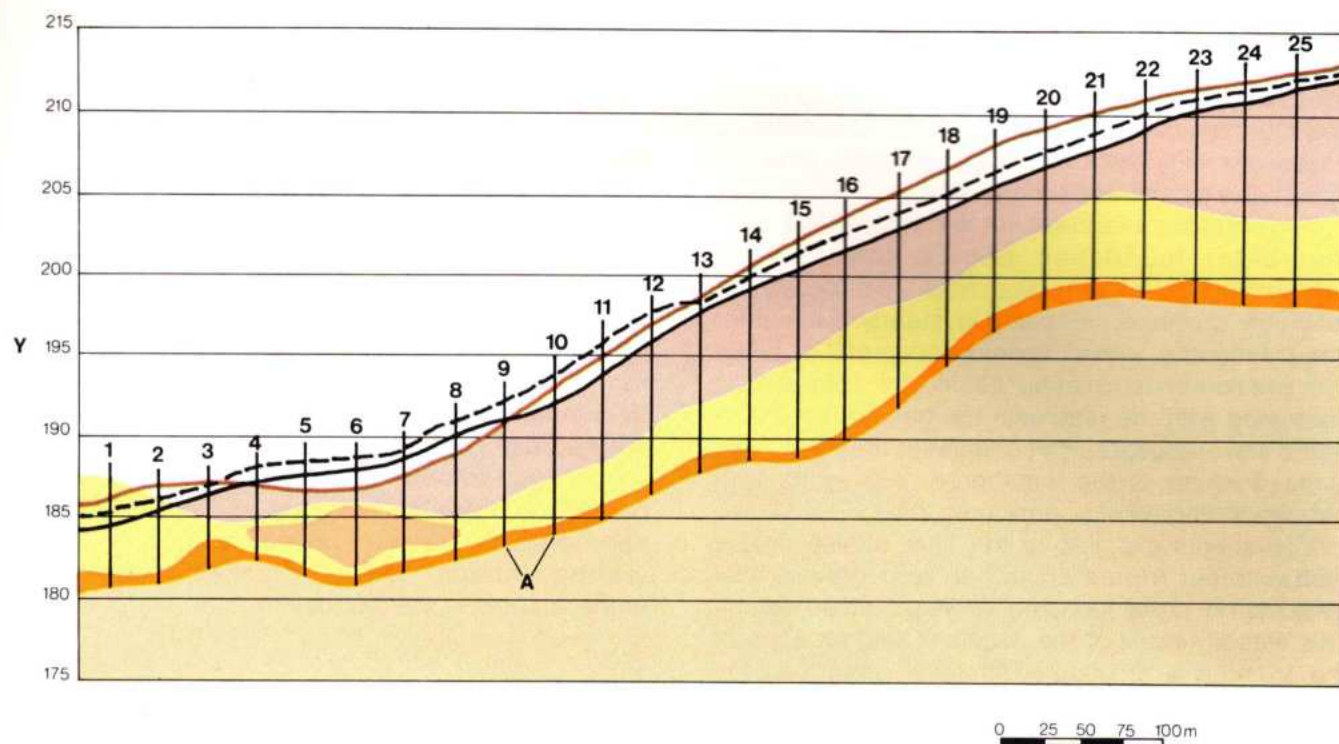
Fig. 7.9 Left earthfill dam longitudinal section at downstream toe of earthfill relief wells

Piezometric pressures and the phreatic gradient under the left earthfill dam, reached steady levels 1 to 2 years after reservoir filling. While the steady piezometric levels were lower than those assumed in the design, they varied for different sections of the dam, depending upon the properties and depth of the foundation soils overlying basalt. Water levels at

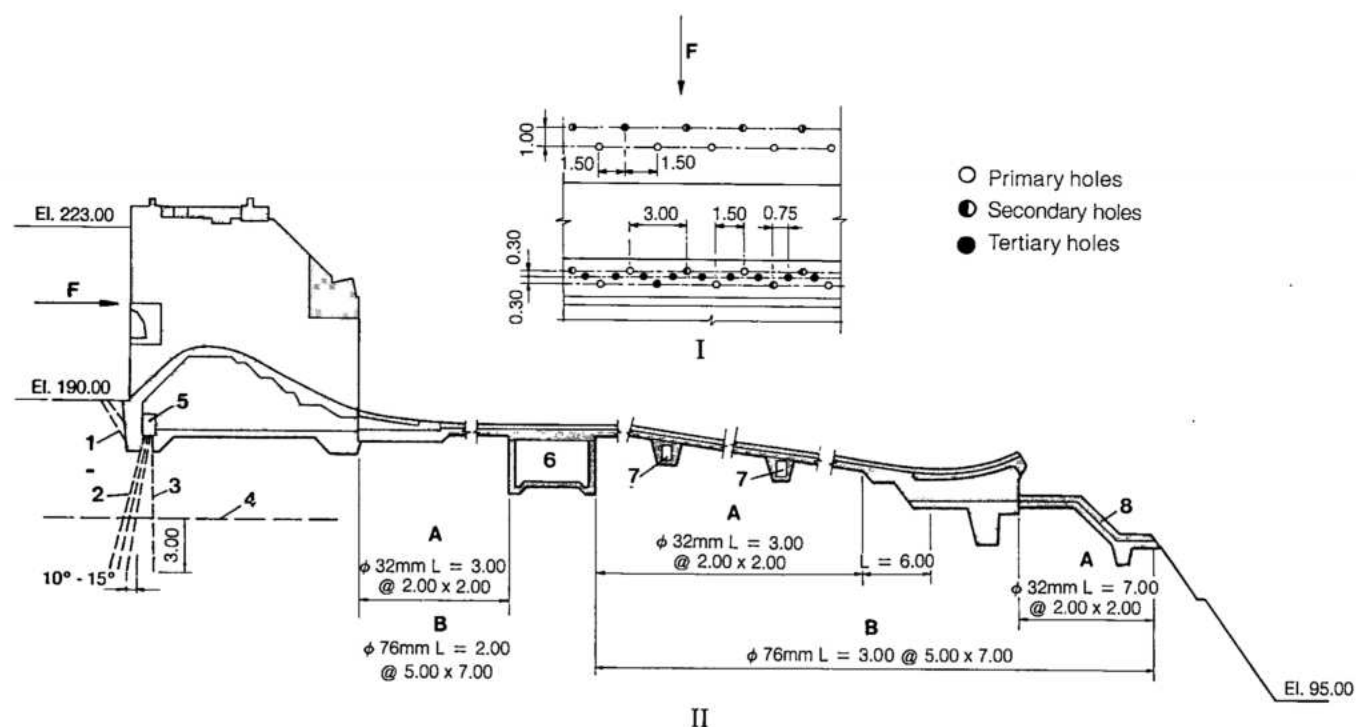
Fig. 8.22 Foundation treatment and concreting

The flip buckets were designed as mass concrete gravity structures bonded to the rock foundation. The foundation was trenched to form a 5 m deep key under each bucket. Since the lateral loads which the bucket structure had to

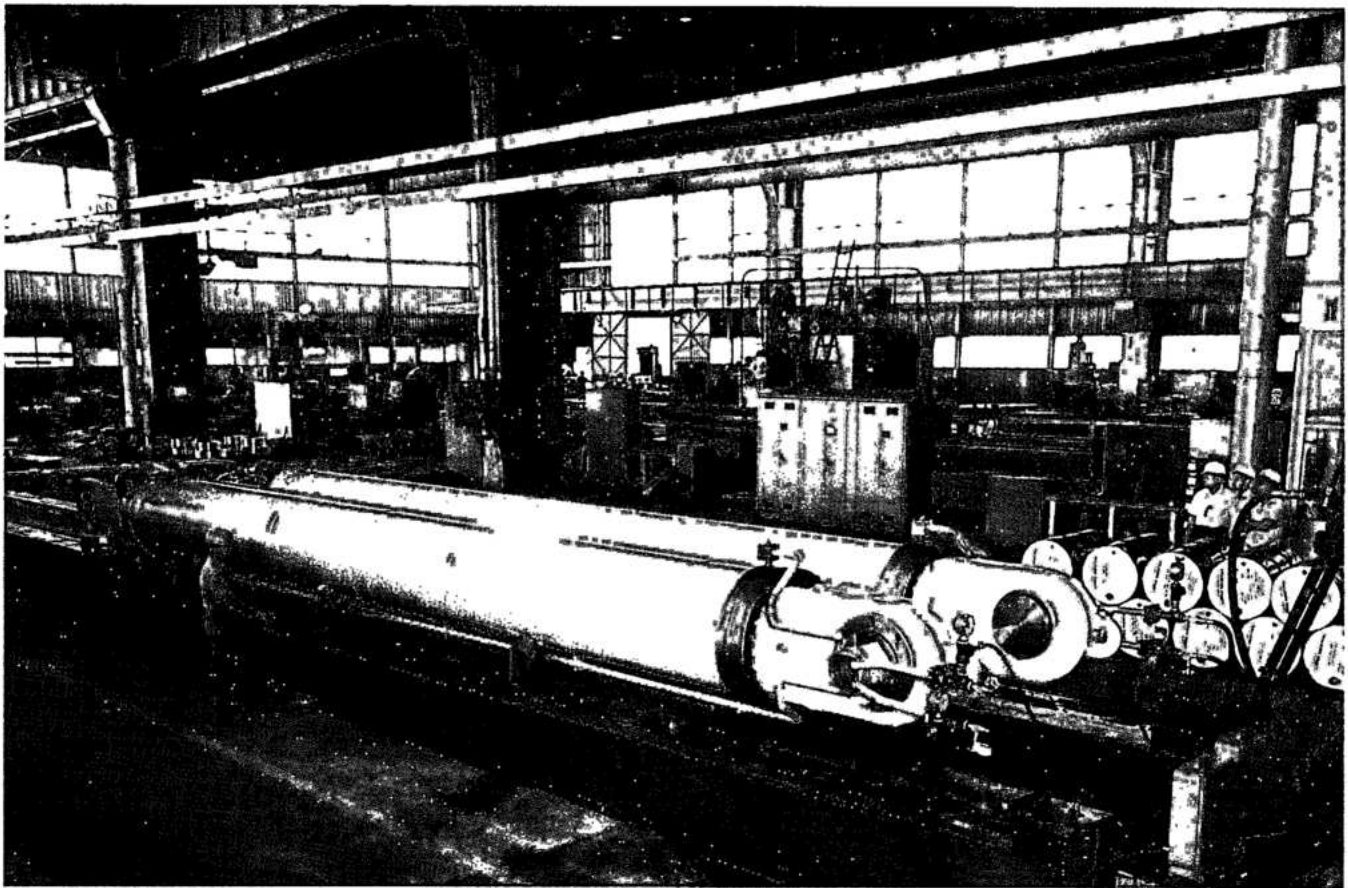
Servomotors were designed to the ASME Boiler and Pressure Vessel Code and were hydrostatically and functionally tested in the workshop.

Testing of spillway gate servomotor in manufacturer's works

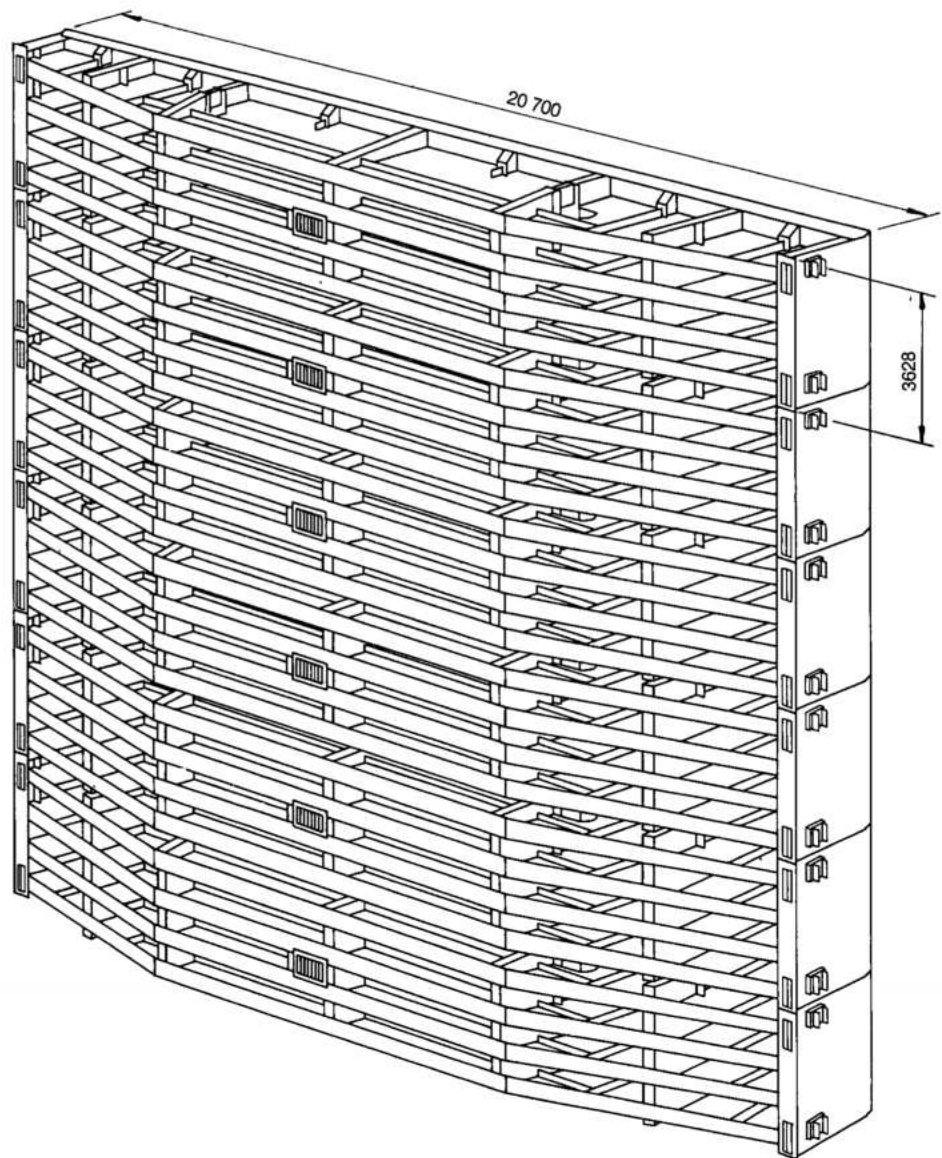
Fig. 8.34 Spillway stoplog arrangement

| 4 Motor | 8 Lateral pulley |

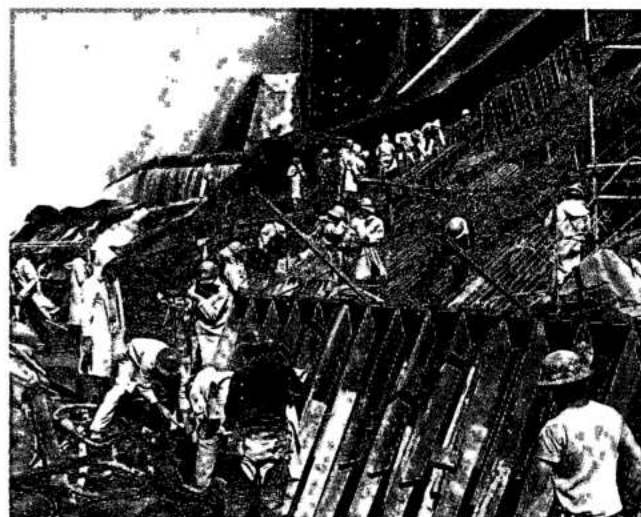
Repair of eroded downstream slopes

discharge through the left chute was decreased to allow a thorough inspection of the slope below the central chute. It was found that the erosion was extensive, but it was decided that the need for repairs was not immediate. Repairs were carried out from October to December 1986, using the same procedures as for the left chute area. Work conditions at this site were extremely difficult. The adjacent left chute was always operating, creating persistent spray and strong winds, caused by negative pressure under the spillway jets together with eddy currents and rough waves in the river. A 1 m high cofferdam was built with sandbags to protect the personnel and the work area. Ropes were attached to rock bolts along the water line for safety of personnel.

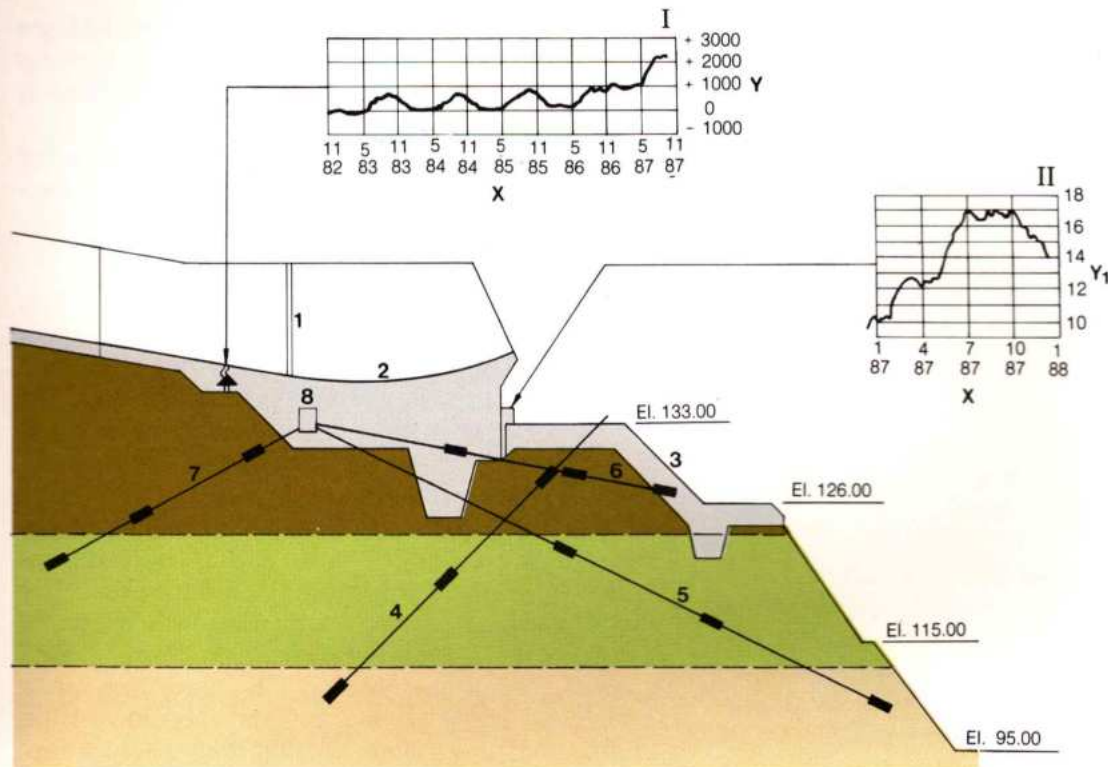
Fig. 8.44 Instrumentation of joints between buckets and protection slabs (right chute)

However, in November 1986 during summer, it was observed that the contraction joints in the walls, instead of closing, continued to open further. At that time inspection of the right and central buckets showed that the joints between the buckets and the downstream protection slabs had an opening of 10 and 3 mm, respectively. To monitor these joints, five sets of triorthogonal markers were installed, four along the width of the right chute and one in the middle of the central chute, see Fig. 8.44.

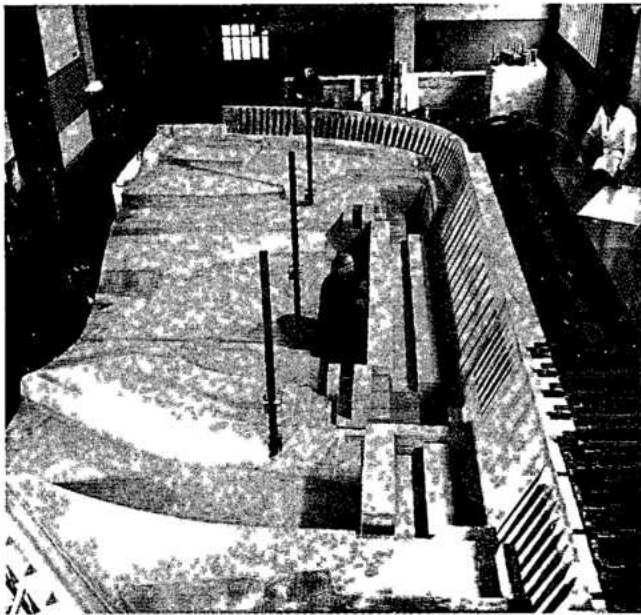
limestone and baryte bonded with resin emulsions was used. These materials had a deformability modulus of 20 to 25 kN/cm² and compressive strength of 30 to 40 N/cm². The addition of glycerine stabilized the water content of the material, thus reducing shrinkage. For the rock layers mixtures of powders bonded with dielectric oils were used. These mixtures, when suitably compressed produced materials having low mechanical characteristics: compression modulus with a minimum value between 50 and 70 kN/cm² and compressive strength between 6 and 10 N/cm². Even at such low values, these mixtures gave a good simulation of the deformation and strength characteristics of the modelled rocks. The lower rock layer from El. - 70 to El. 0, was cast in place.

Geomechanical model

To further ensure compliance with the specified parameters, all the upper layers from El. 0 up to El.180, were built with bonded pre-cast blocks. Each block of concrete structures (dam and powerhouse) was cast in place; so that it would be structurally independent from the adjoining blocks, a varnish coat was applied to its sides.
